# Evaluation of Grounding System Maintenance at JIS Jakarta School Building

<sup>(1)</sup>Program Studi Teknik Elektro, Universitas Tama Jagakarsa, Jakarta

DOI: 10.31004/jutin.v8i2.42727

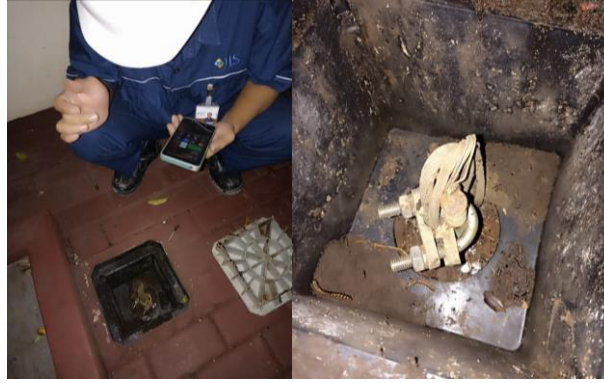
**Fig. 1. JIS 1 and JIS 2 Grounding Testing**

The grounding resistance test data obtained showed variations in resistance values at several installation points in the field. The test results were compared with the standards set by electrical regulations (<5 ohm for residential systems or <1 ohm for industrial systems). The following is the Grounding Resistance Test on JIS 1 and JIS 2 Building

Figure 1 Periodically inspect the physical condition of the grounding cables, electrodes, and grounding connections to ensure there is no damage or corrosion.

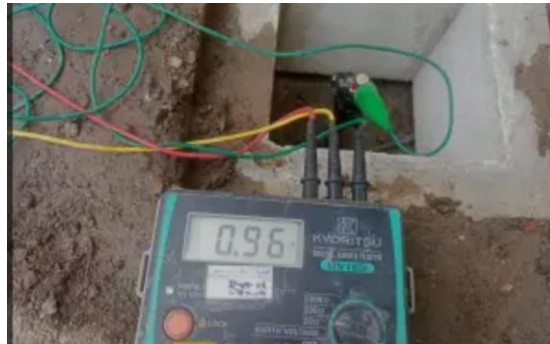
**Fig. 3. The result of repairing and adding electrodes to the Server panel**

The following is the approach method for planning the improvement of the Server Panel area grounding. In the Server Panel grounding system has 1 electrode with a depth of 2.5 meters resistance value of 5.38 ohms. To achieve a value below 0.99, the electrodes needed are as follows:

To improve the grounding value that is not in accordance with the standard, the project will make a planning approach by adding rod stick points or deepening the rod stick. So that the grounding resistance value can be in accordance with the expected standard.

Then the required electrode value is 5.43 or 6 electrodes, and if you want to get a grounding value with 1 earthing, the required depth is :

From the results of table 1 above, it is known that the grounding improvement value on the Server panel is -4.39 Ohm, which we know the addition of the stick rod on the server panel reaches a value of 0.96, this proves that the results of the formulation get almost appropriate results.

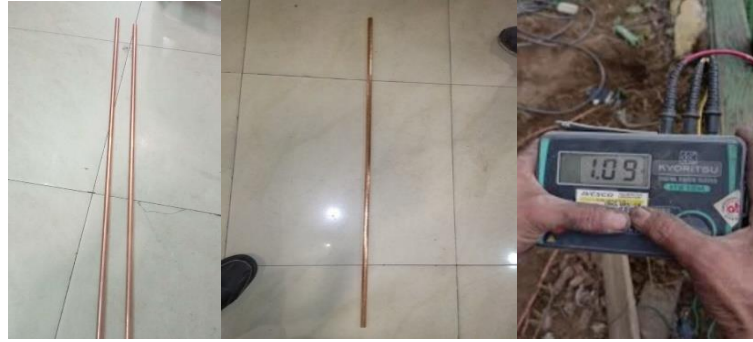
**Fig. 4. Repair results and addition of electrodes on the Alarm panel**

Furthermore, the results of the Alarm Panel area grounding improvement planning method. The Alarm Panel grounding system has 1 electrode with a resistance value of 7.56 ohms with a depth of 2 meters, where the land area for adding electrodes is not possible, only 2 points can be added with a distance of 3 meters from the main point by dismantling the floor. To achieve a value below 1.2 Ohm, the electrode depth required is as follows:

Then the depth that needs to be added is 0.3174 meters or 32 cm and if you want to add 1 point back, the value obtained is as follows:

Here are the results of the earthing improvement approach to the alarm panel system.

As for improvements to the Alarm panel, it gets an improvement value of -6.36 by adding a depth of 32 cm. we know that the calculation results get a value of 1.20 Ohm. Due to this improvement, the combination of watering the salt water media with the addition of the depth of the stick rod, the results obtained are 1.09 Ohm, where watering with salt water media can certainly increase the reduction of resistance by 0.11 Ohm.
